The why and how of an “explosive circumstance”

An explosion makes a building collapse, causing the death of four people, injuries to other ten and 3,000,000 Euros worth of damage. Thanks to our scrupulous technical expertise, it was possible to ascertain the cause of the explosion and establish the legal and insurance responsibility.

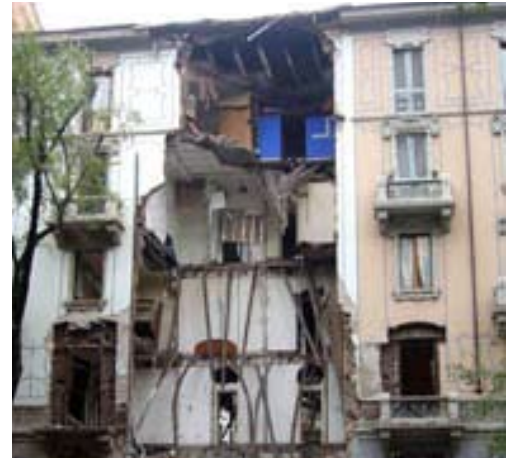
Façade of building: street view – most damage done here

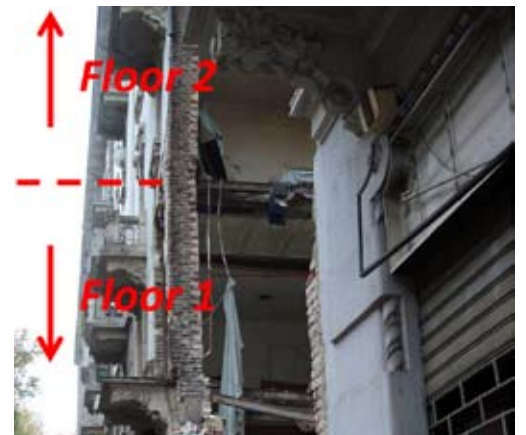
- The main damage was on the first floor
- The floors above had less damage
- The façade on the first floor had been driven outwards and the worst-hit area was situated under the sill between the first and second floors, as if the origin were towards the ceiling of the apartment.
- One of the floor beams bent out leftwards (the other ones had been thrust downwards by the load-bearing wall of the façade), as if pressure had been applied from right to left and from the top towards the bottom.
- The doors had been thrust outwards in an orthogonal direction from the house by the shock waves made by the explosion.

Façade of first floor thrust outwards – the area of maximum warping between the first and second floors

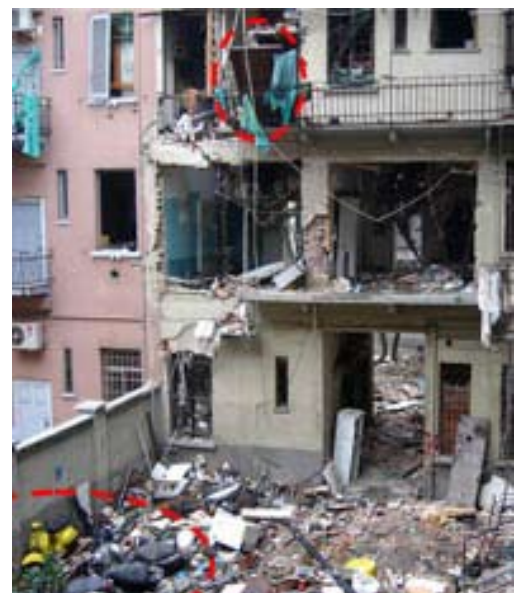
Building seen from courtyard – the shock waves from the explosion pushed the doors outwards and the moped lumped together.
