## The causes of darkness

The failure of an aerial high-tension cable caused a 20-hour blackout involving 1500 families, with damages over 2,000,000 Euros. Our meticulous technical expertise found the cause and the solution to the problem.

The failed item was an aerial high-tension cable made up of 5 rings of aluminium alloy wires.

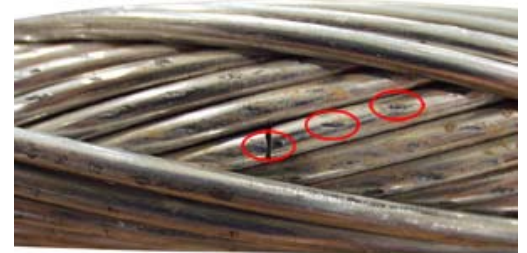
- The fretting induced a wear-and-tear effect on the wires, creating the debris and the oval spots from which the fracture spread

- The fretting was due to oscillation caused by wind hitting the high-tension wires.

Visual analysis of the cable – the oval spots made by fretting are evident.

**We found the cause of the fracture and set up corrective measures. A number of dampers were applied to the high-tension wires in order to limit oscillation. No failures ever occurred again.**

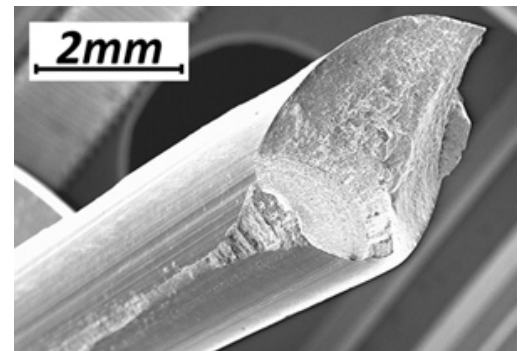
- Numerous fractures in the fourth and fifth rings
- Dark-coloured debris
- Oval spots on the fourth ring
- A typical fatigue fracture surface emanating from the oval spots.

Fracture surface – the cracking emanating from the oval spot is evident.

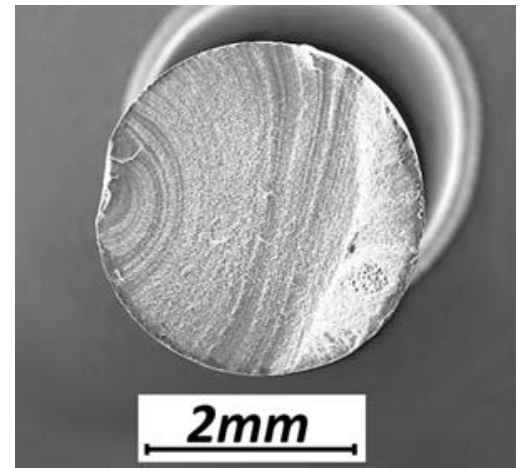
**• The failure was definitely due to fretting between the wires of the fourth and fifth rings**

Fracture surface – typical morphology of fatigue fractures.
