A sea of problems

The explosion of a muffler in a yacht led to its being grounded for 8 months with damages of over 7,000,000 Euros. Thanks to our skilled technical expertise, we found the cause of the breakdown and the solution to the problem

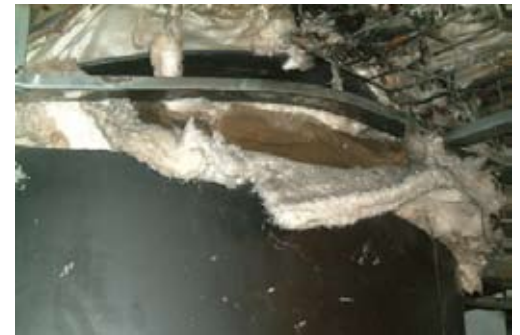
- Extensive deformation in proximity to the fracture and bulging in the centre of the top disk.

• The failure was due to a mechanical overload because of elevated pressure.

Muffler – the elevated deformation due to muffler explosion is evident
